# INSTALLATION MANUAL

TURBO ACTUATOR

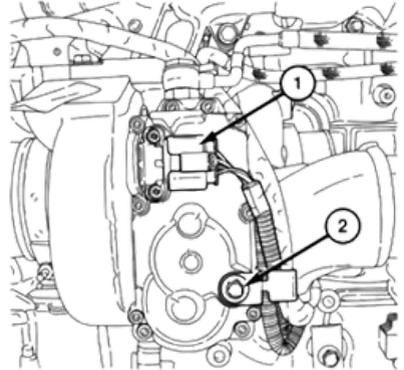
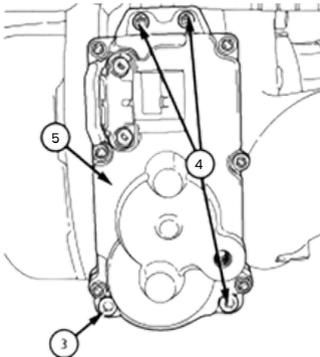
Remove bolt (2) securing the wiring harness to the turbocharger actuator.

Unplug the electrical connector (1) from the turbocharger actuator.

Remove bolts (3) and (4) and remove the turbocharger actuator (5).

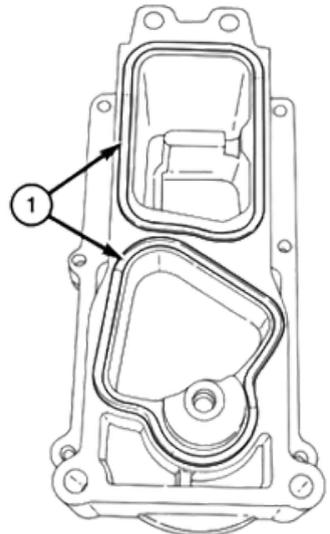
Clean the sealing surfaces on the turbocharger to ensure the actuator has a proper seal after installation.

Install new rubber seals onto the actuator.

Do **NOT** plug in the electrical connector.

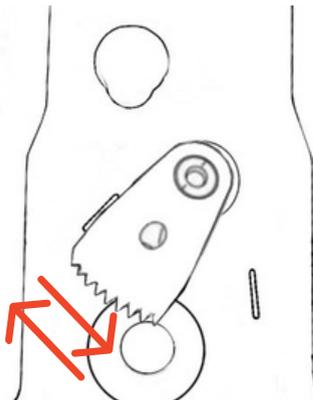
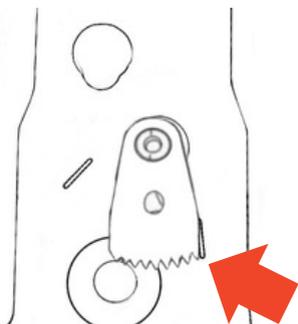
Grasp the sector gear by hand and rotate it back and forth, checking for smooth movement.

1.2013–2025 models: the gear must sweep freely between the reference lines.

2.2007–2012 models: no reference lines are present; the gear must still move freely.

*If there is any tightness or resistance, the turbocharger is seized and must be replaced.*

Apply grease to the teeth of the sector gear to reduce noise.

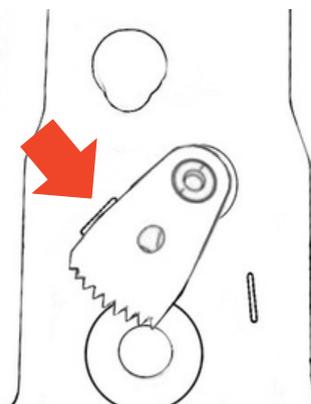
Position the sector gear fully to the left, toward the turbine housing (hot side, firewall side).

*The sector gear must always be positioned to the left. Do not attempt to align any holes or notches.*

(hot side / firewall / cab)

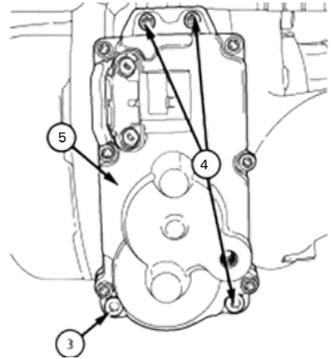
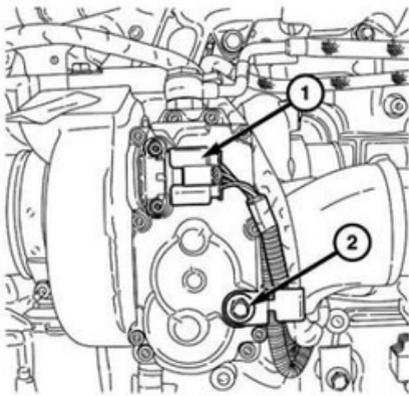
Tighten all actuator mounting bolts to 90 in-lbs.

Using an Allen wrench, tighten the remaining cap screw (3) until it is flush with the actuator body. Once the screw is flush with the actuator housing, tighten it an additional 90 degrees.

Do not install the wiring harness retaining bolt at this time.

Install bolt (2) securing the wiring harness to the turbocharger actuator and tighten to 11 N·m (8 ft-lbs).

Plug in the electrical connector (1).
